DEPARTMENT OF TRANSPORTATION**DIVISION OF ENGINEERING SERVICES**

Contract #: 04-0120F4Cty: SF/ALA Rte: 80 PM: 13.2/13.9File #: 1.28**WELDING INSPECTION REPORT****Resident Engineer:** Casey, William**Address:** 333 Burma Road**City:** Oakland, CA 94607**Report No:** WIR-026756**Date Inspected:** 22-Nov-2011**Project Name:** SAS Superstructure**OSM Arrival Time:** 700**Prime Contractor:** American Bridge/Fluor Enterprises, a JV**OSM Departure Time:** 1730**Contractor:** American Bridge/Fluor Enterprises, a JV**Location:** Job Site**CWI Name:** Bernie Docena**CWI Present:** Yes No**Inspected CWI report:** Yes No N/A**Rod Oven in Use:** Yes No N/A**Electrode to specification:** Yes No N/A**Weld Procedures Followed:** Yes No N/A**Qualified Welders:** Yes No N/A**Verified Joint Fit-up:** Yes No N/A**Approved Drawings:** Yes No N/A**Approved WPS:** Yes No N/A**Delayed / Cancelled:** Yes No N/A**Bridge No:** 34-0006**Component:** SAS OBG**Summary of Items Observed:**

Caltrans Office of Structural Material (OSM) Quality Assurance Inspector (QAI) Joselito Lizardo was present at the Self Anchored Suspension (SAS) job site as requested to perform observations on the welding of components for

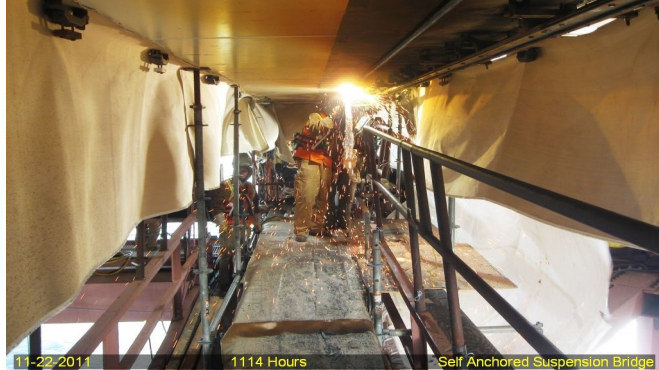
At OBG 13E/14E bottom plate 'D2' outside, QA randomly observed ABF personnel Jin Pei Wang continuing to perform plasma arc gouging on the backing bar removal of the non-SPCM splice butt joint. The welder was using an Esab plasma arc gouging machine that has the nozzle holder attached to a Bug-o track. Gouging of the backing bar was not completed today and should continue tomorrow.

At OBG 13E/14E bottom plate 'D2' outside, ABF personnel were noted performing plasma arc gouging on the backing bar removal of the welded splice butt joint.

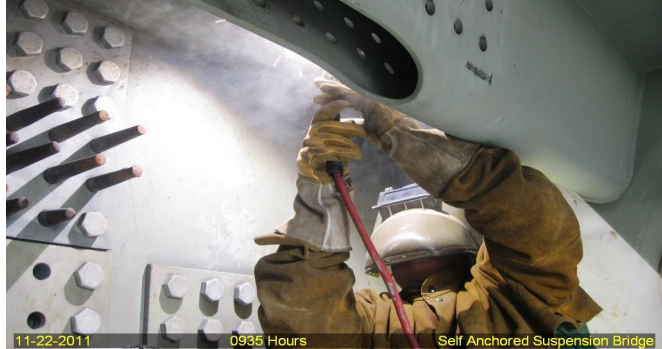
At OBG 14E-PP125-E3-#3 and #4 lifting lug hole infill plates to top deck plate inside, ABF welder Salvador Sandoval was observed performing 4G Shielded Metal Arc Welding (SMAW) back welding fill pass to cover pass on the infill plate to top deck plate butt joints. The welder was noted using 1/8" diameter E7018H4R implementing Welding Procedure Specification (WPS) ABF-WPS-D15-1110A Rev.1 for the Seismic Performance Critical Member (SPCM) butt joint. Prior back welding, ABF QC Bernie Docena was observed performing Magnetic

At OBG 14E-PP125-E3-#3 lifting lug hole infill plate to top deck plate inside, ABF welder Salvador Sandoval was observed performing 4G Shielded Metal Arc Welding (SMAW) back welding fill pass to cover pass on butt joint.

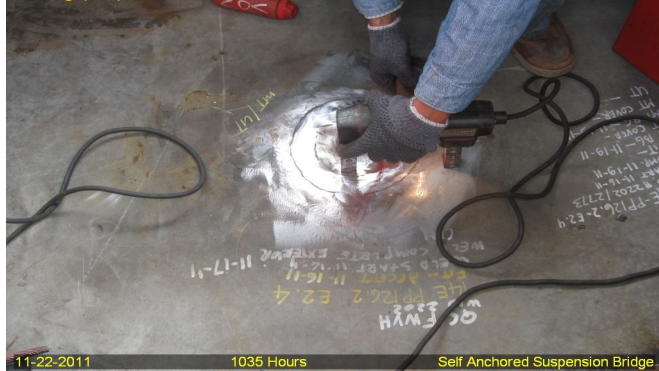
1. OBG 14E-PP126.2-E2.4 vent hole infill plate to deck plate outside - QA VT/MT verified
2. OBG 14E-PP126.7-E2.5 vent hole infill plate to deck plate outside - QA VT/MT verified
3. OBG 14E-PP126.2-E2.6 vent hole infill plate to deck plate outside - QA VT/MT verified

At OBG 14E-PP126.2-E2.4 vent hole infill plate to top deck plate outside, ABF QC Bernie Docena was observed performing Magnetic Particle Testing (MT) on welded vent hole.
